Groveton Water Department
Water System Leak Detection Survey Report
2016

July 8, 2016

Groveton Water Dept
PWSID# 1781010

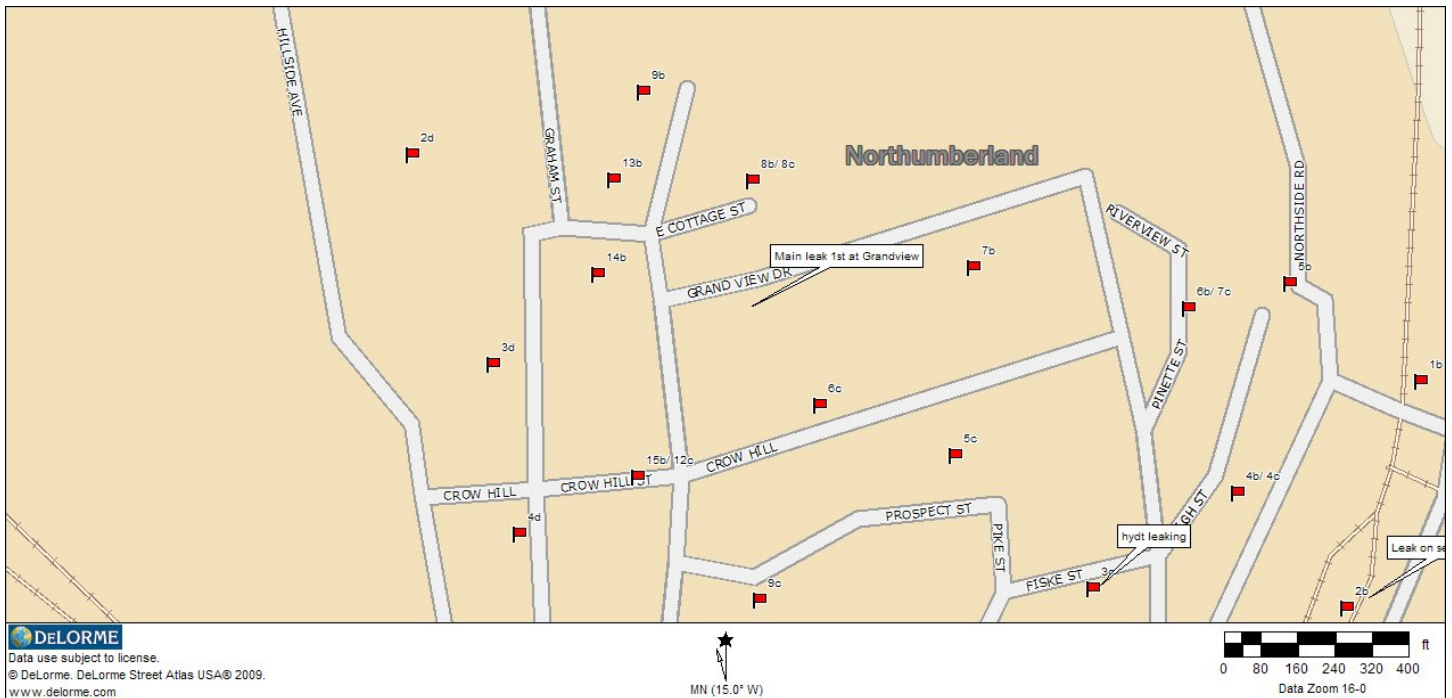
Location: 1st Street at Grand View, Main Leaking

Approx. Size: 25-50 gpm, Type of Surface Cover: Asphalt

Pipe Material; CI

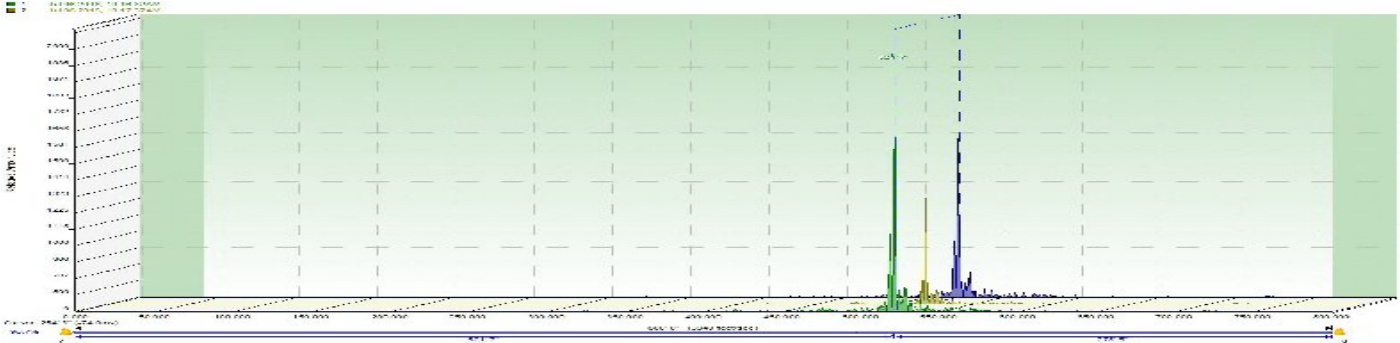
Date and Time of detection on Correlation

Pipe ID	Length	Diameter	Material	Sound Velocity
P7	500' 0"	8"	Cast Iron	3940 feet/sec
P8	300' 0"	8"	Cast Iron	3940 feet/sec

Leak ID	Leak Position	Correlation Between	Confidence	Recording Time
L28	52' 1" 7" from 7	7 → 8	96.7%	Jul 06 2016, 10:16:32AM
L29	52' 1" 2" from 7	7 → 8	96.1%	Jul 06 2016, 10:17:32AM
L30	52' 0" 4" from 7	7 → 8	96.3%	Jul 06 2016, 10:18:32AM
L31	52' 0" 5" from 7	7 → 13	92.4%	Jul 06 2016, 10:16:32AM
L32	52' 0" 0" from 7	7 → 13	90.1%	Jul 06 2016, 10:17:32AM
L33	52' 0" 5" from 7	7 → 13	91.4%	Jul 06 2016, 10:18:32AM
L76	52' 1" 7" from 7	7 → 8	96.7%	Jul 06 2016, 10:16:32AM
L77	52' 1" 2" from 7	7 → 8	96.1%	Jul 06 2016, 10:17:32AM
L78	52' 0" 9" from 7	7 → 8	96.1%	Jul 06 2016, 10:18:32AM

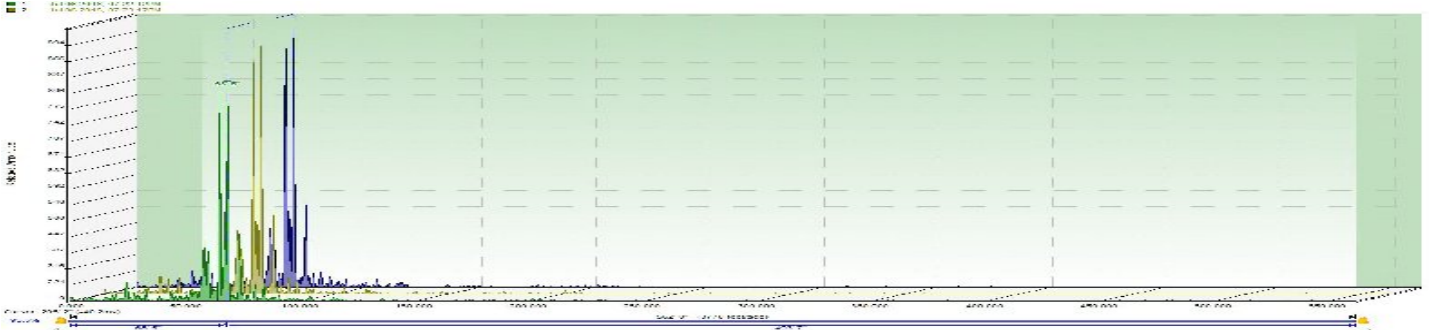
Date and time of detection on correlation

Pipe ID	Length	Diameter	Material	Sound Velocity
P4	562' 0"	12"	Cast Iron	3770 feet/sec

Leak ID	Leak Position	Correlation Between	Confidence	Recording Time
L13	819' 7" from 3	3 → 5	92.9%	Jul 06 2016, 07:22:12PM
L14	820' 4" from 3	3 → 5	92.8%	Jul 06 2016, 07:23:12PM
L15	819' 11" from 3	3 → 5	92.9%	Jul 06 2016, 07:24:12PM
L16	68' 5" from 4	4 → 5	93.5%	Jul 06 2016, 07:22:12PM
L17	68' 5" from 4	4 → 5	93.8%	Jul 06 2016, 07:23:12PM
L18	67' 12" from 4	4 → 5	93.6%	Jul 06 2016, 07:24:12PM
L61	68' 5" from 4	4 → 5	93.8%	Jul 06 2016, 07:23:12PM
L62	67' 12" from 4	4 → 5	93.6%	Jul 06 2016, 07:24:12PM

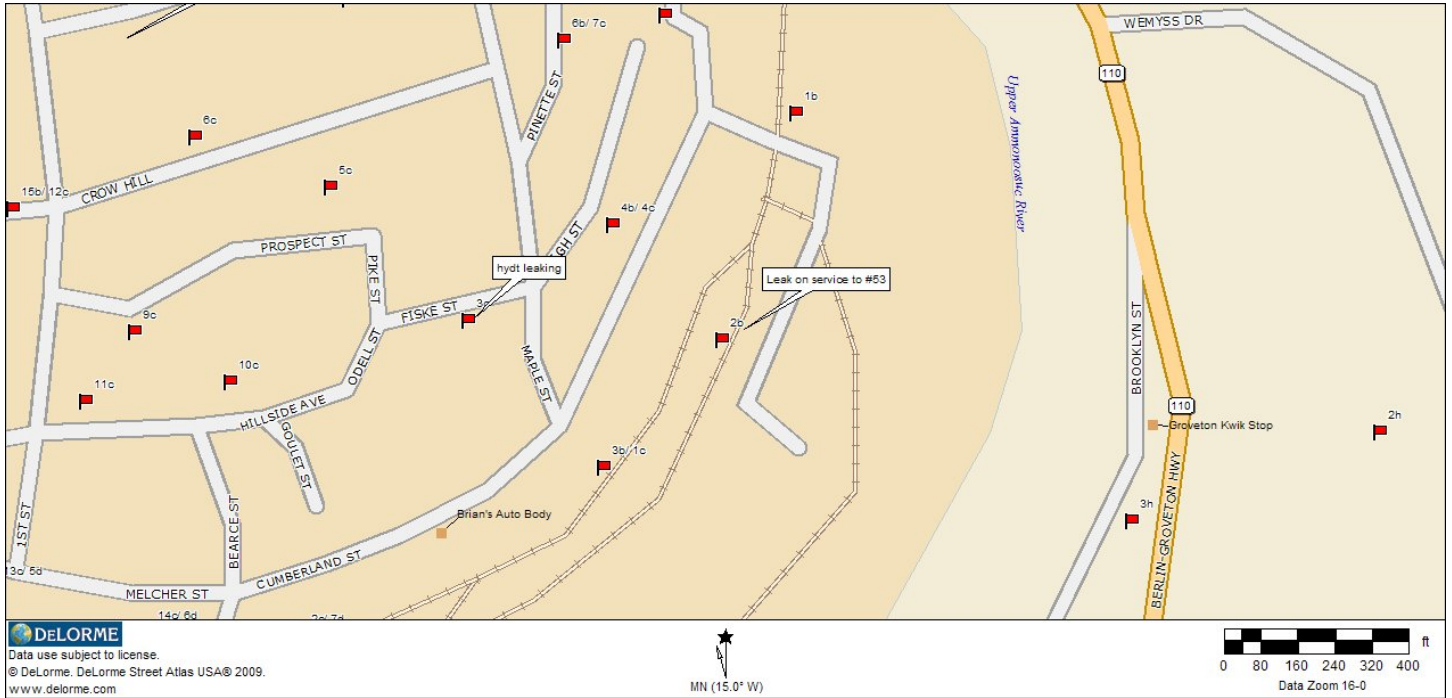
Location: 53 Cumberland St, service leaking,

Approx. Size: 4-8 gpm, Type of Surface Cover: mixed

Pipe Material; unknown

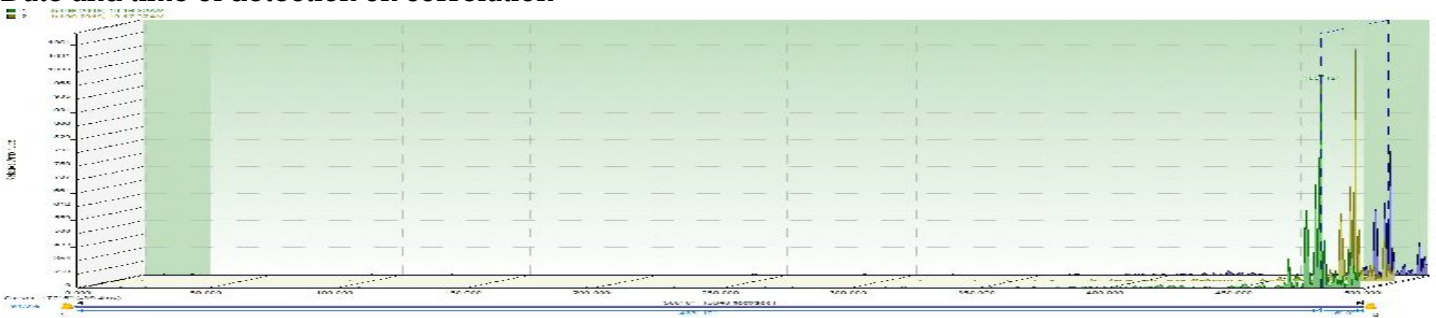
Date and time of detection on correlation

Pipe ID	Length	Diameter	Material	Sound Velocity
P1	500' 0"	8"	Cast Iron	3940 feet/sec

Leak ID	Leak Position	Correlation Between	Confidence	Recording Time
L1	483' 12" from 1	1 → 2	94.3%	Jul 06 2016, 10:16:32AM
L2	484' 5" from 1	1 → 2	94.7%	Jul 06 2016, 10:17:32AM
L3	484' 10" from 1	1 → 2	93.6%	Jul 06 2016, 10:18:32AM
L4	469' 8" from 1	1 → 3	94.2%	Jul 06 2016, 10:16:32AM
L5	470' 1" from 1	1 → 3	93.8%	Jul 06 2016, 10:17:32AM
L6	470' 1" from 1	1 → 3	93.3%	Jul 06 2016, 10:18:32AM
L67	483' 12" from 1	1 → 2	94.3%	Jul 06 2016, 10:16:32AM
L68	484' 5" from 1	1 → 2	94.7%	Jul 06 2016, 10:17:32AM
L69	484' 10" from 1	1 → 2	93.6%	Jul 06 2016, 10:18:32AM

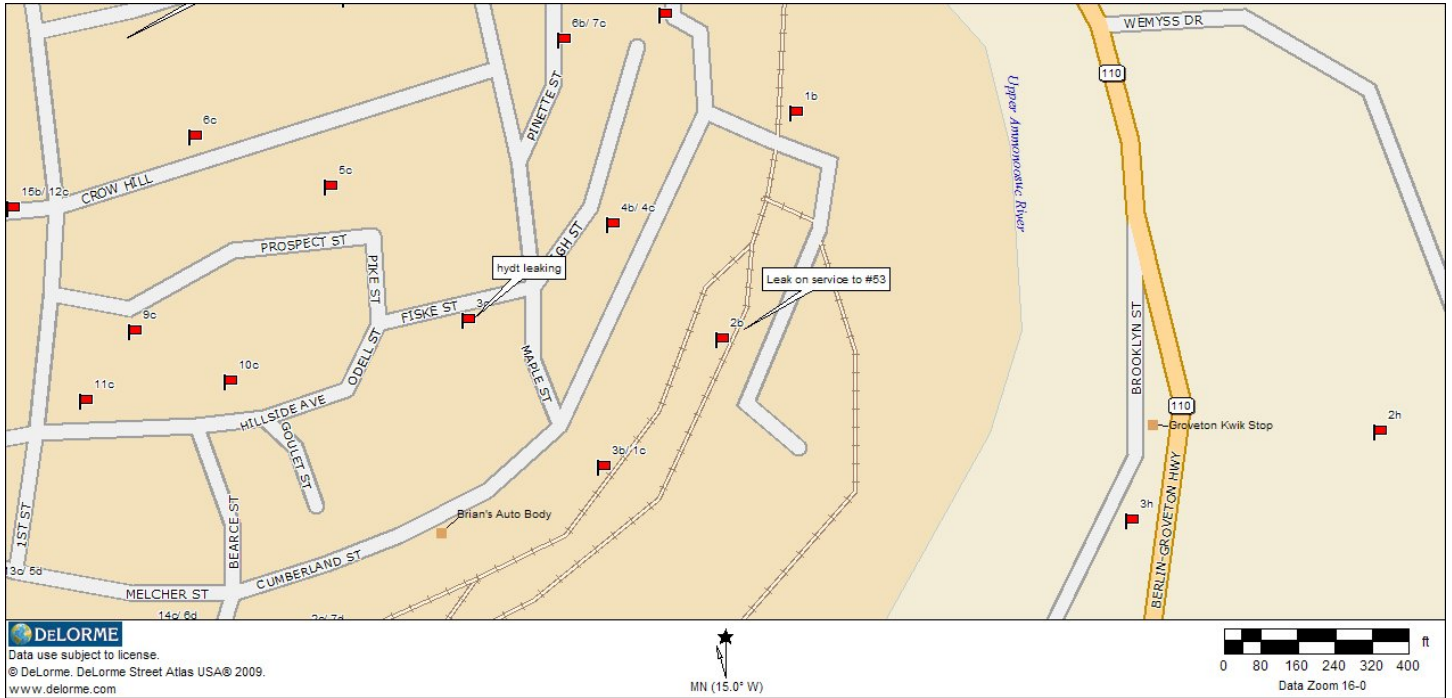
Location: Odell by Fiske, Hydrant leaking,

Approx. Size: 1/2-1 gpm, Type of Surface Cover: mixed

Pipe Material; unknown

Detected on review of logger recordings
